DTV Channel 6 Interference to FM Band Reception

Laboratory Test Report

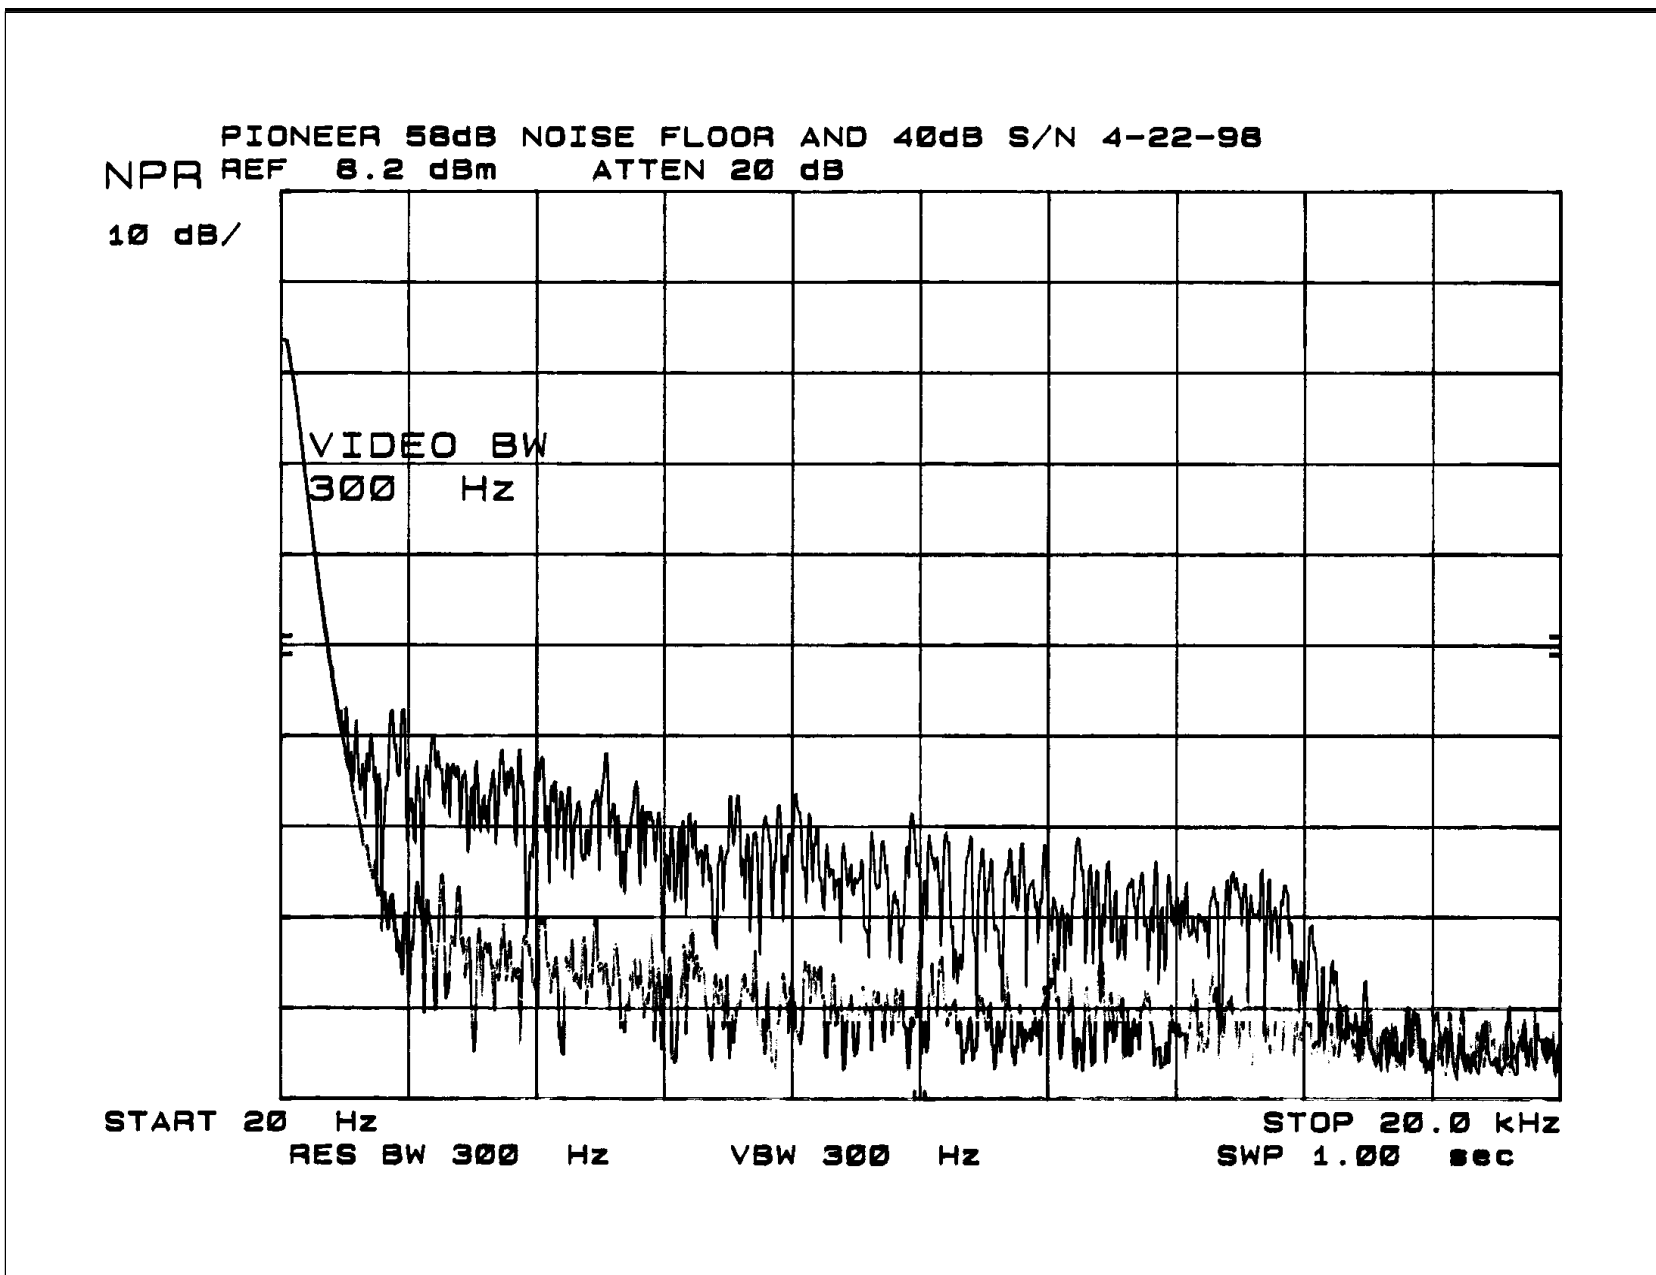
Pioneer Noise Floor Plot
